Naval Research Laboratory

MTADS UNEXPLODED ORDNANCE OPERATIONS AT THE BADLANDS BOMBING RANGE AIR FORCE RETAINED AREA

*PINE RIDGE RESERVATION, SD
SEPTEMBER, 1999*

Naval Research Laboratory, Washington, DC

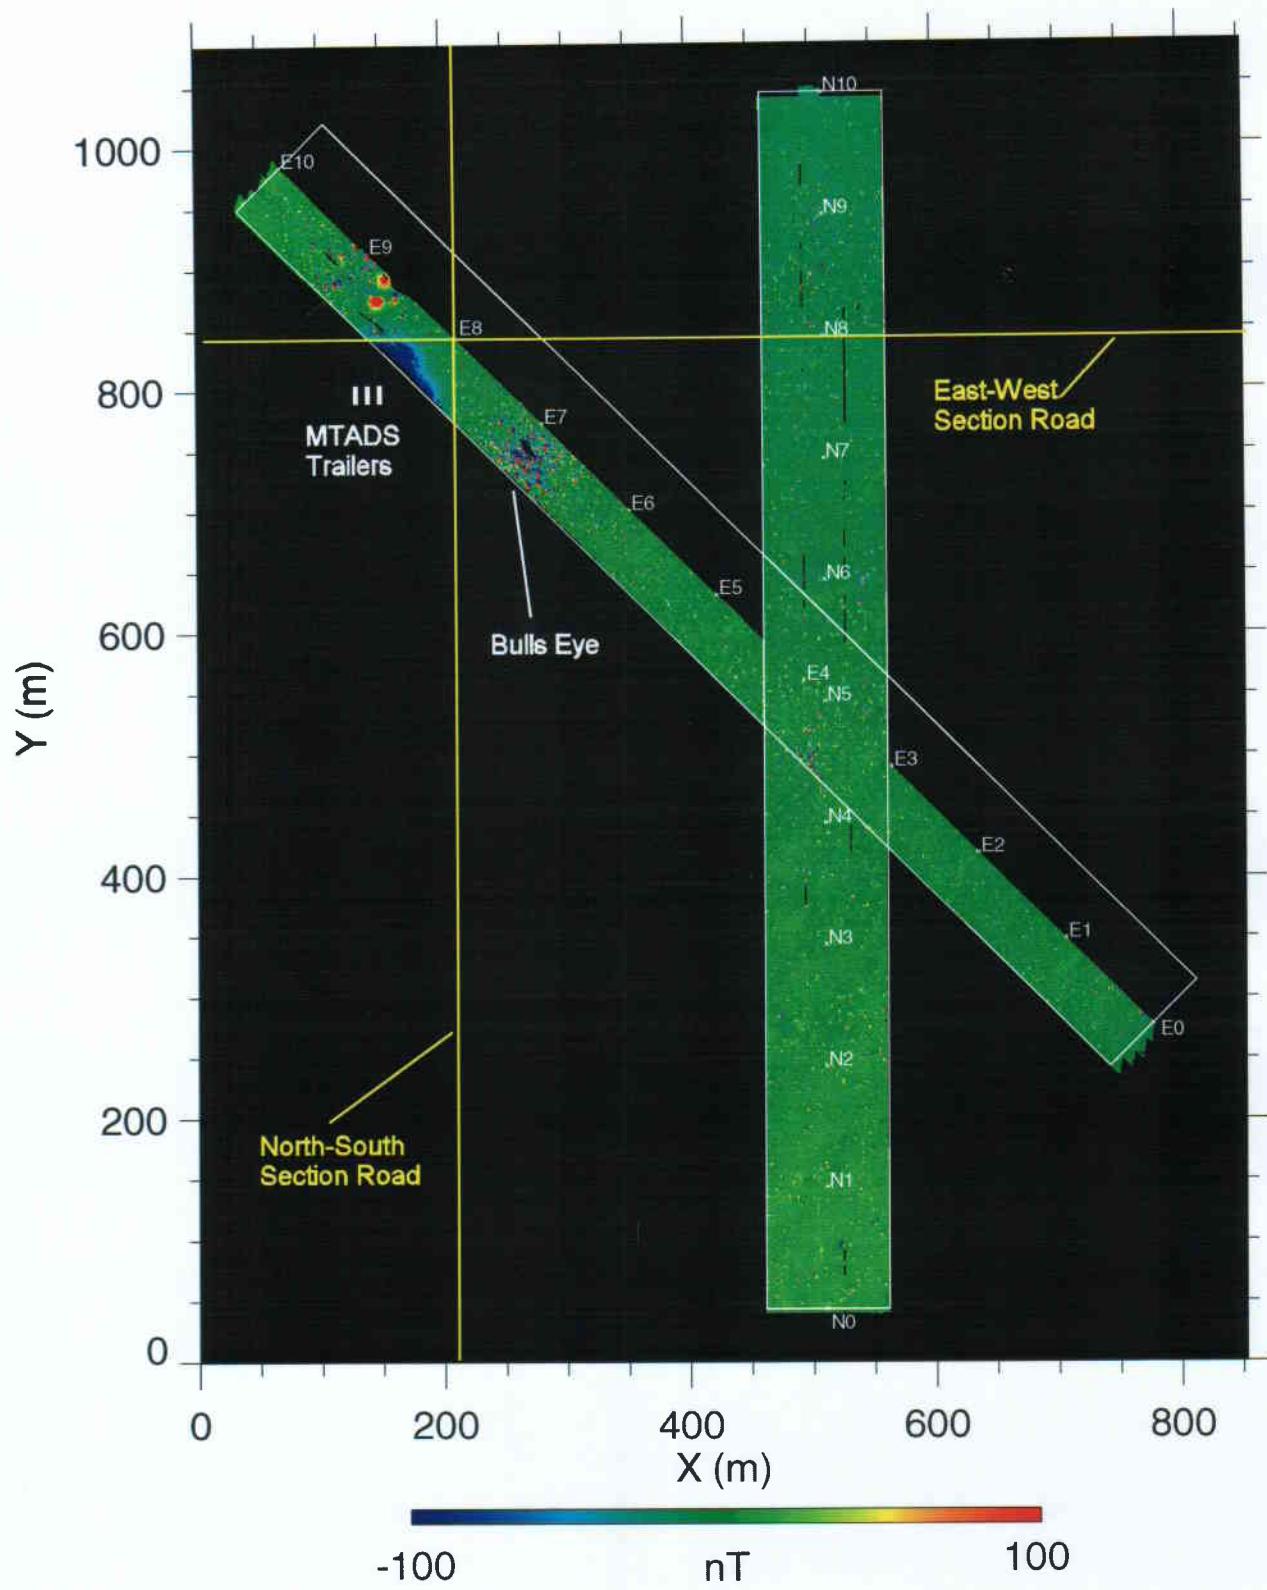
Figure 8. Magnetic Anomaly image of the North-South and the Northwest-Southeast Transects.

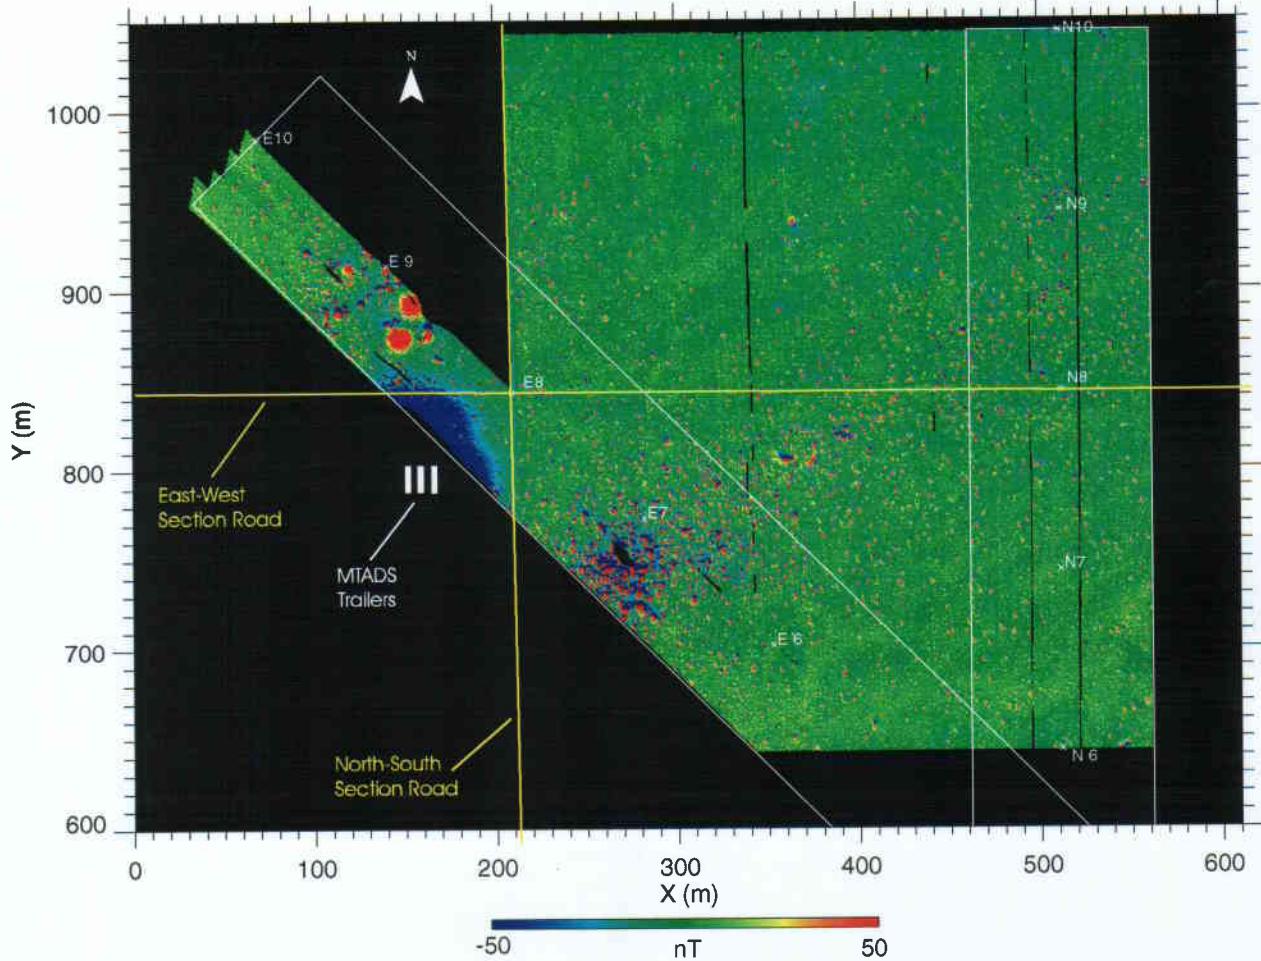
Figure 9. Magnetic anomaly image map of the North Site showing the bull's eye and the overshoot pattern.

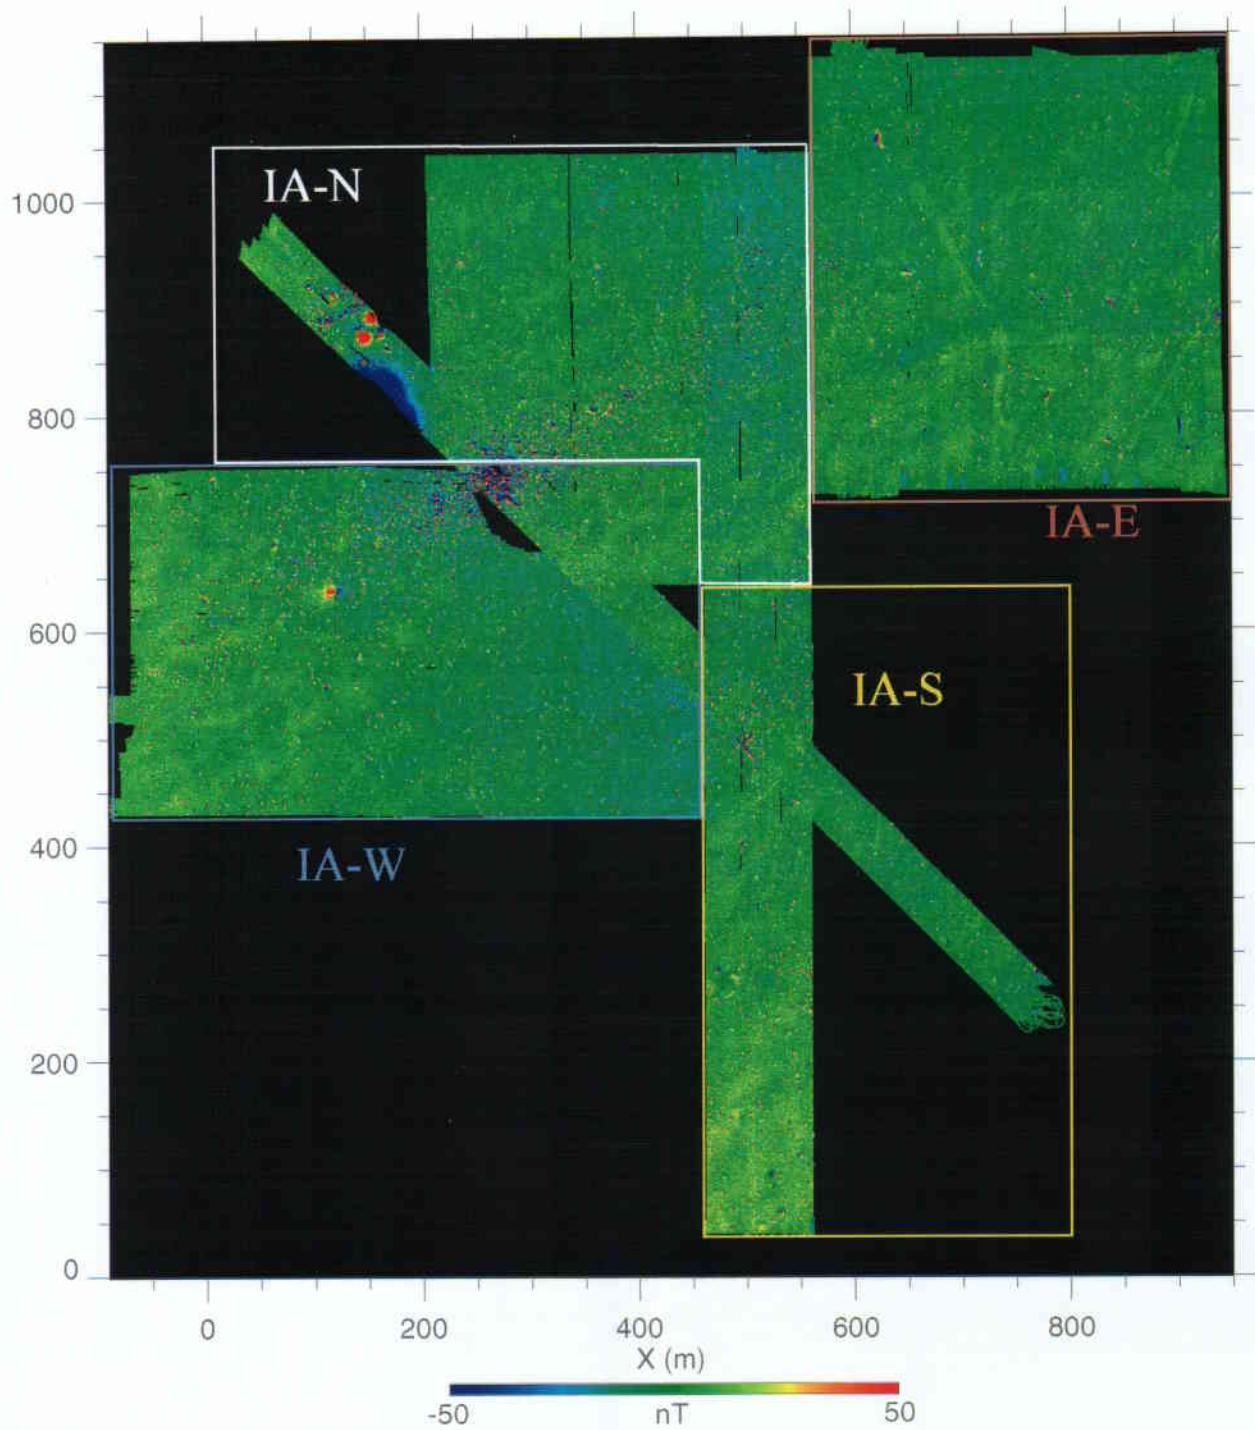
An overview of the magnetometry survey is shown in Figure 10. For analysis purposes the survey was broken into 4 data sets. The area bounded in yellow, called Impact Area South (IA-S), was analyzed and dug first, as described below. The area bounded in blue is Impact Area West (IA-W). The final block that was surveyed is called Impact Area East (IA-E). It is bounded in red in Figure 10. The remaining area, bounded in white, is Impact Area North (IA-N).

Figure 10. Magnetic anomaly image map of the areas surveyed on the Impact Area. The South Site is bounded in yellow, the West Site in blue, the East Site in red, and the North Site in white.

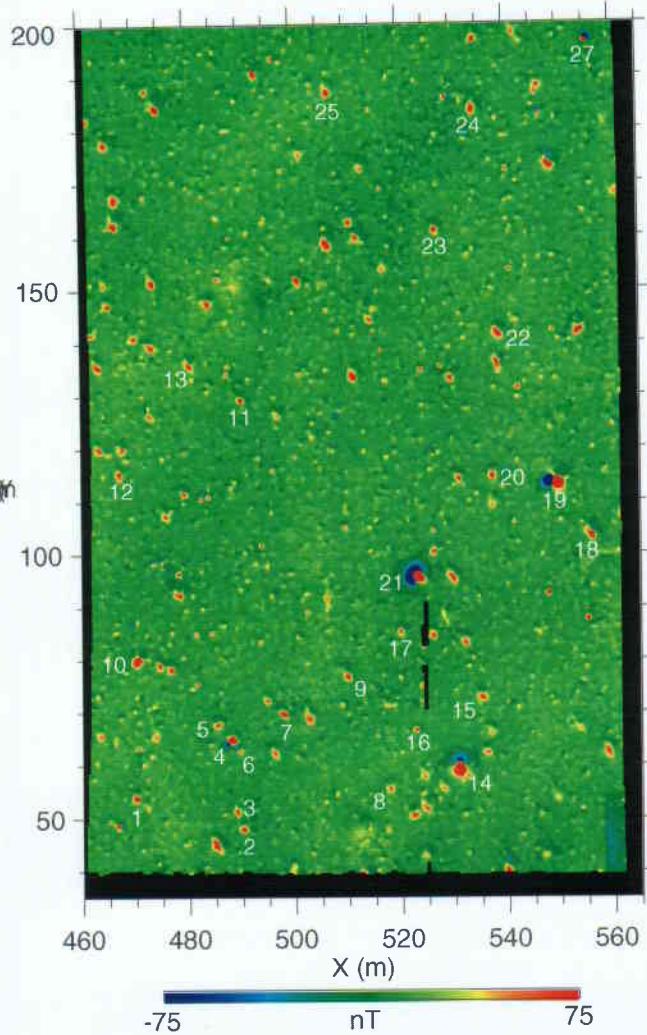
Figure 13. Example of a dig image used by the way pointing team to reacquire and flag targets and by the remediation team in preparation for digging. In this image target 14 is a 155-mm projectile and target 21 is an 8-inch projectile.

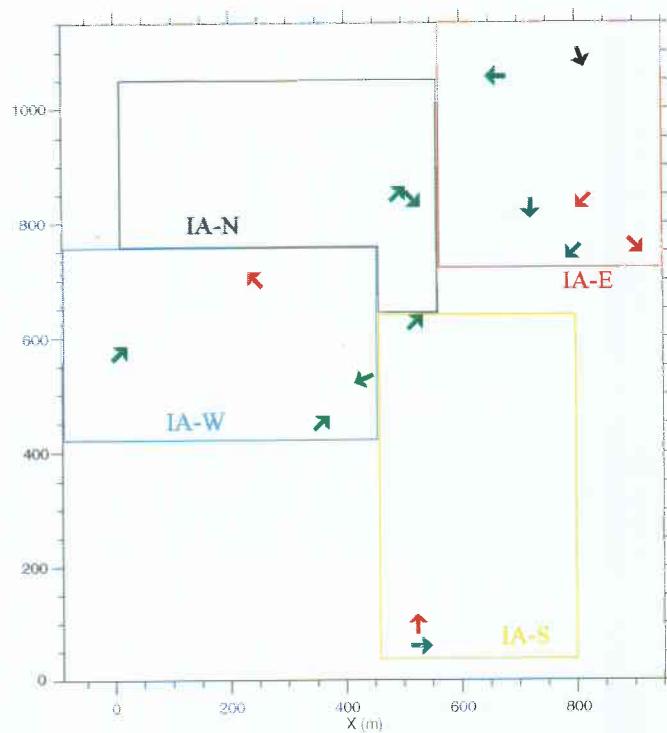
Figure 14. Distribution of projectile duds on the Impact Area Survey. 155-mm projectiles are noted in green, 8-in shells in red.

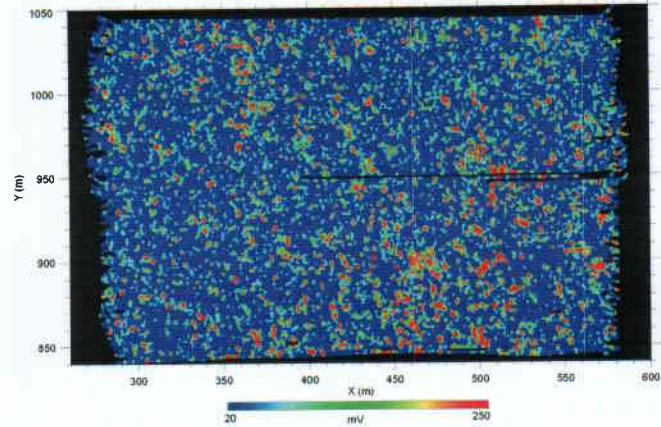
Figure 20. EM anomaly image of a portion of IA-N from the East/West survey.

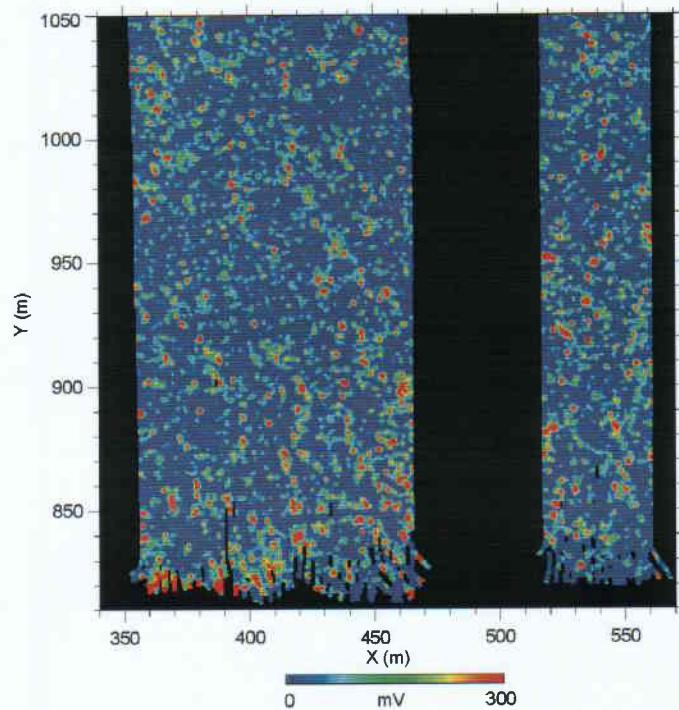
Figure 21. EM anomaly image of the section of IA-N surveyed in a North/South direction.

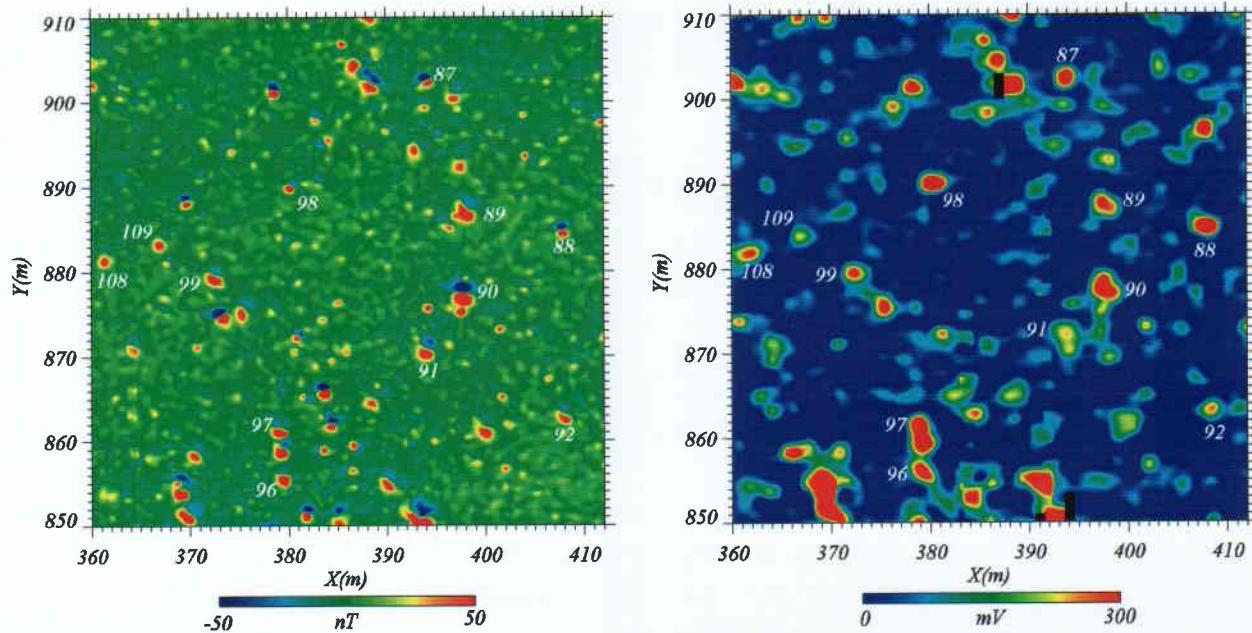
5.6.2 Field data from the Fusion Survey. In Figure 23 are shown the magnetometry and one of the EM analysis windows for a small portion of the joint analysis that was performed on this data. Target numbers from several representative fitted targets are shown from the fusion analysis. Targets were chosen only from the area that was covered by both of the orthogonal EM surveys and the magnetometry survey. In general, fusion targets were chosen that were not complicated by overlapping signatures from other nearby buried metallic objects. The fusion analysis was carried out without paying particular attention to the sizes of the objects being analyzed. Numerous targets were chosen that were significantly smaller than the analysis threshold that was used on the remainder of the site (assuming that 105-mm projectiles were the smallest ordnance of interest).

Figure 23. MTADS Fusion Data Analysis from IA-N showing simultaneous target selections from the magnetometry and North/South EM surveys.

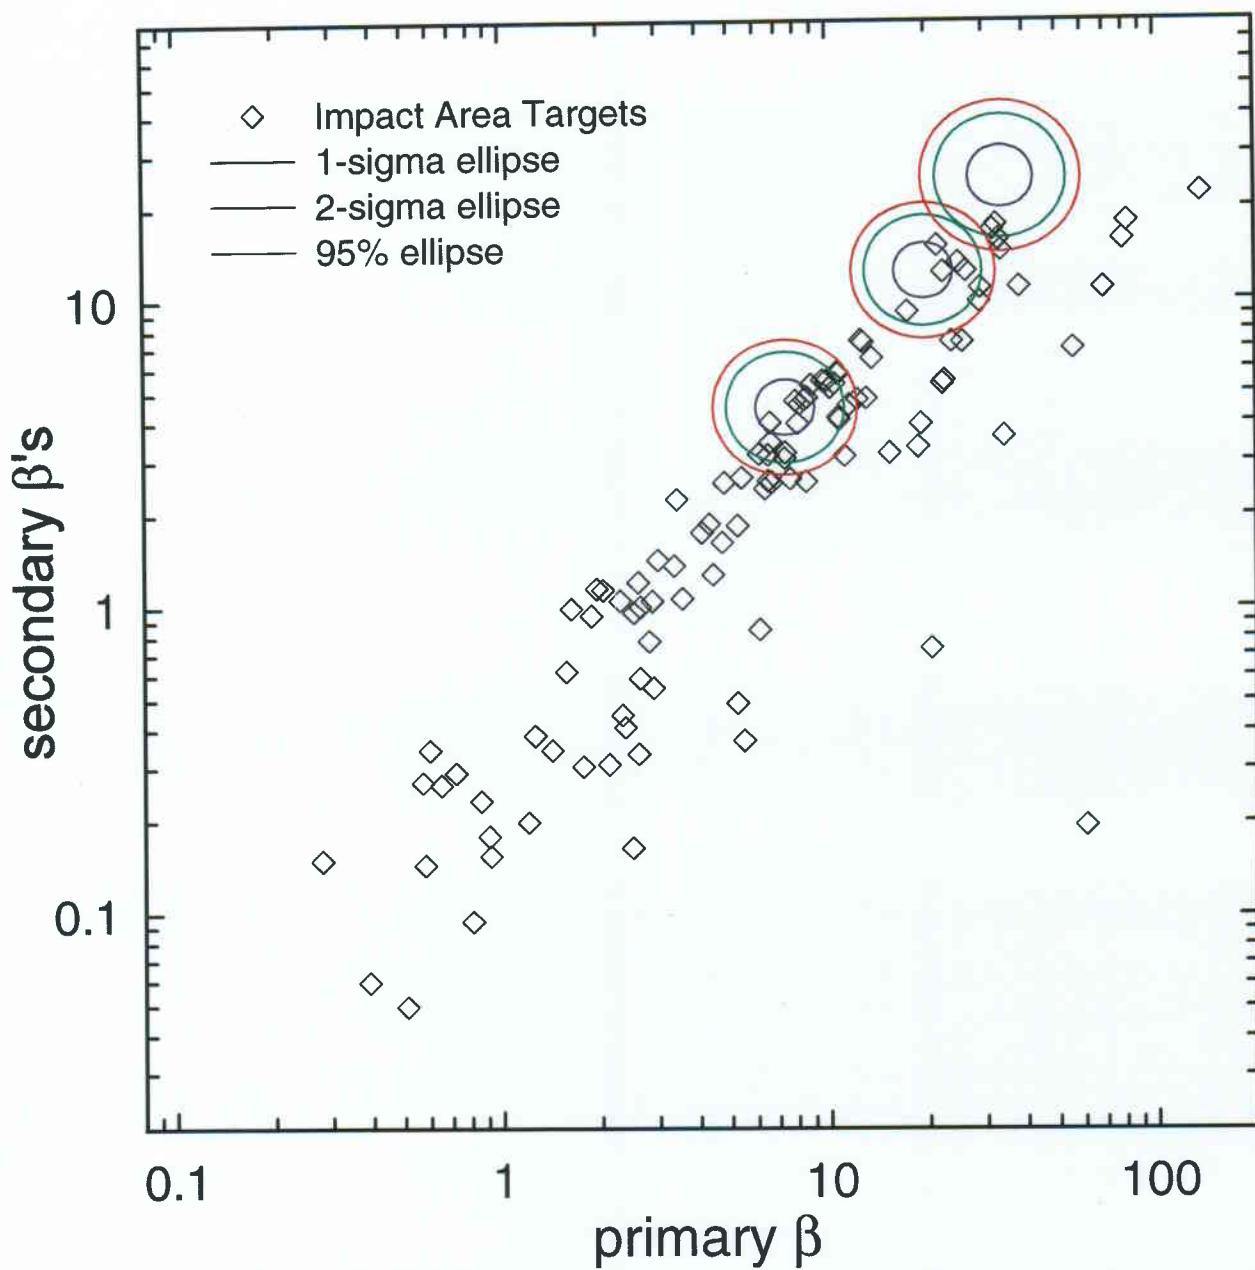
Figure 24. The 3β fusion analysis of the 109 selected targets from the fusion survey area. The lower target is a 105-mm projectile, the center target is a 155-mm and the upper target is an 8-in projectile.
